**Evaluation of Compliance of Urban Land Use Zones to Integrated Land Use Plan in Meru Municipality, Meru County, Kenya****James Muthomi Riungu*, Moses Njeru Kathuri**

Department of Social Sciences, Faculty of Humanities and Social Sciences, Chuka University, Kenya

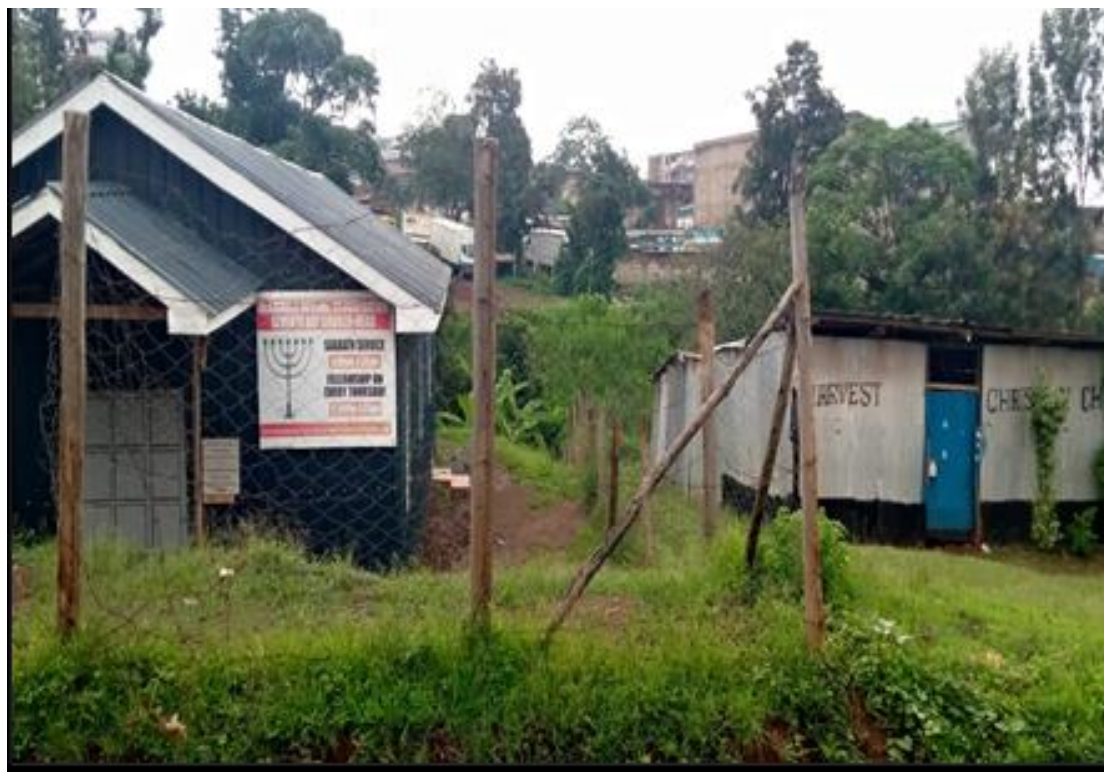
Figure 1. Non-compliance in an Industrial Zone

20.4% of plot coverage compliance was observed in garages. The study observed churches in the industrial zone as shown in Figure 1.

The churches had been constructed to adjust to each other. The churches were supposed to be constructed in public utility zones yet they were in industrial zones leading to incompatibility of land use. The study identified ten churches' industrial zones. The developers said that they targeted the industrial zone where there was vast land lying idle. The number of industries was far less compared to the total land allocated for industries. The study found out that many developers could not raise the capital required for the development of industries hence hiring their land for other land uses such as the construction of churches.
